**Flood Control Project Maintenance
Levee Inspections**
LMA District Cover Sheet
Spring 2018 Levee Inspection Results

Tehama County Flood Control and Water Conservation District

Spring 2018 Levee Inspection Results

Waterway			Bank	Unit Miles
Unit No. 01 Deer Creek			Left	4.22
	Spring (March - May)	Summer (June - August)	(September - November) Fall	Winter (December - February)
Unit Maintenance Rating (Fall Only)				
Date of Inspection	4/4/2018 - 4/4/2018			
DWR Inspector	Bob Duffey			
Accompanied By	Ryan Teubert Tehama County

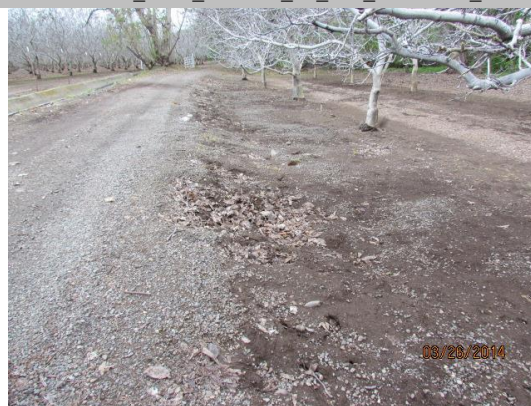
Photo 1 of 1 : SP_2018_NA0019_78_276_20180305_00024.jpg

LM Start	0.45	Rating **	M	Issue No.	276
LM End	0.45	Issue Type +	Ma	Location *	WS
Category	Earthen Levee			GPS Latitude/Longitude	
				Start	End
Item	Slope Stability			39.972377 °	39.972377 °
				-121.988559 °	-121.988559 °
DWR ID	DWR_NA0019_01_s_2014_276				
Comment Code					
S1 : Repair slope instability.					
Inspector Comment

View of the erosion along the waterside slope.

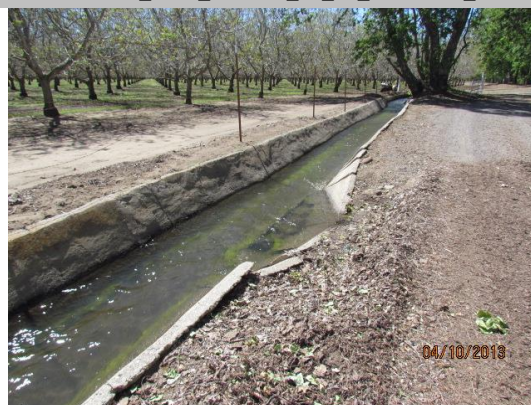
Photo 1 of 1 : SP_2018_NA0019_78_19_20180305_00007.jpg

LM Start	0.46	Rating **	M	Issue No.	19
LM End	0.46	Issue Type +	Ma	Location *	LS
Category	Earthen Levee			GPS Latitude/Longitude	
				Start	End
Item	Erosion / Bank Caving			39.972339 °	39.972339 °
				-121.988763 °	-121.988763 °
DWR ID	DWR_NA0019_01_s_2013_19				
Comment Code					
E1 : Note and monitor erosion site.					
Inspector Comment

View of the erosion along the landside slope.

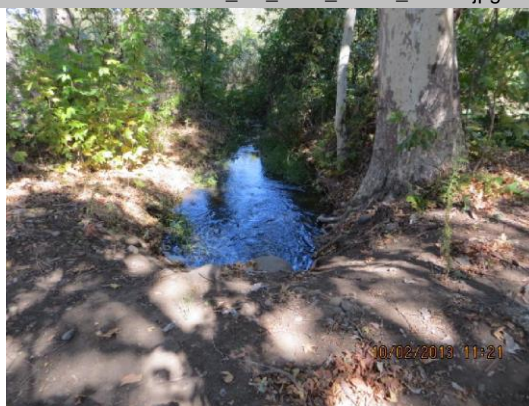
Photo 3 of 3 : UCIP_SP_2018_39839_39061.jpg

LM Start	0.49	Rating **	M	Issue No.	279 (cont)	
LM End	0.49	Issue Type +	En	Location *		
Category	Supplemental			GPS Latitude/Longitude		
				Start	End	
Item	DWR UCIP Field Study			39.972280 °	39.972280 °	
				-121.989227 °	-121.989227 °	
DWR ID						
Comment Code						
Inspector Comment						
FS_ID:39839 DS_ID:24686 EP_NO: N/A Repair Type: Non-Urgent Crossing Status: Found UCIP Comments: No permit identified for crossing. FIELD_STRUCT_DESC: 20-inch reinforced concrete irrigation pipe through the levee, 2 feet below the crown. Concrete canal and distribution structure with slat boards on the landside (LS) shoulder. FS Date: 10/2/2013

Pipe visible at outlet on WS toe.

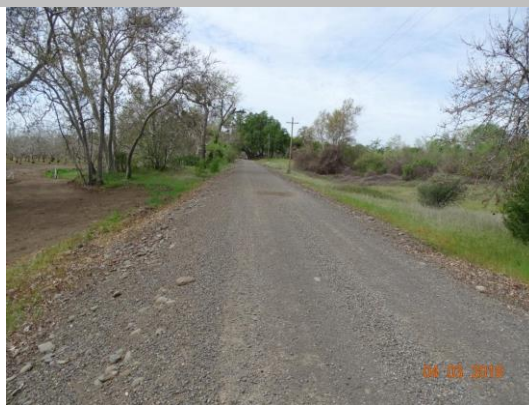
Photo 1 of 1 : SP_2018_NA0019_78_50_20180405_00067.jpg

LM Start	0.76	Rating **	A	Issue No.	50
LM End	0.76	Issue Type +	Ma	Location *	LS
Category	Earthen Levee			GPS Latitude/Longitude	
				Start	End
Item	Vegetation			39.971605 °	39.971605 °
				-121.994137 °	-121.994137 °
DWR ID	DWR_NA0019_01_s_2018_50				
Comment Code					
V1 : Control annual grass and weeds on the levee slopes and easements.					
Inspector Comment					
The vegetation was removed from both slopes.

View of no vegetation on both slopes.

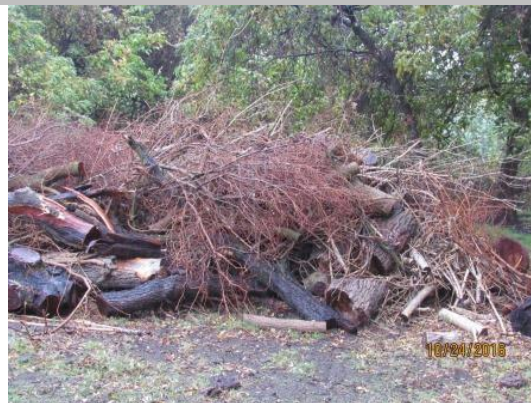
Photo 1 of 1 : SP_2018_NA0019_78_31_20180305_00010.jpg

View of the prunings along the waterside slope.

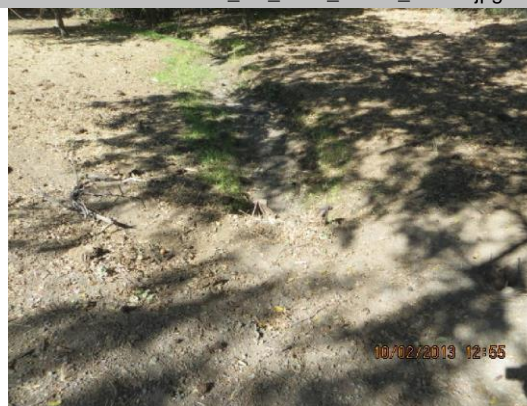
Photo 3 of 3 : UCIP_SP_2018_51437_36920.jpg

Comment Code						
Inspector Comment						
FS_ID:51437 DS_ID:20770 EP_NO: N/A Repair Type: Non-Urgent Crossing Status: Found UCIP Comments: 12/05/2016 Sediment buildup inside pipe (see photo) and sediment buildup on WS blocking flap gate. Crossing has been downgraded from Urgent to Non-Urgent crossing was closed on both WS and LS. (O. Magana - DWR UCIP)10/02/2013 Flapgate blocked by soil buildup. (W. Wylie - DWR UCIP) FIELD_STRUCT_DESC: 24-inch steel drainage pipe through the levee, 1.5 feet below the crown. Flap gate on the waterside (WS) toe. [Additional Reference(s): DWR Levee Log, 1992. USACE Sacramento O&M Manual Unit 509, March 1957, As-built drawings available 50-4-2394 (Station 185+40)]. FS Date: 12/5/2016

Outlet on WS toe.

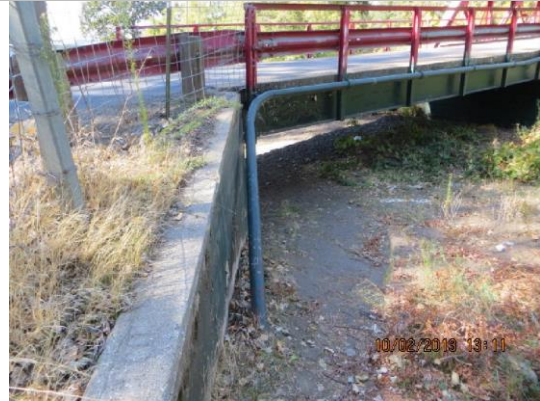
Photo 3 of 3 : UCIP_SP_2018_39837_39065.jpg

LM Start	1.88	Rating **	M	Issue No.	281 (cont)	
LM End	1.88	Issue Type +	En	Location *		
Category	Supplemental			GPS Latitude/Longitude		
				Start	End	
Item	DWR UCIP Field Study			39.969156 °	39.969156 °	
				-122.013809 °	-122.013809 °	
DWR ID						
Comment Code						
Inspector Comment						
FS_ID:39837 DS_ID:24690 EP_NO: N/A Repair Type: Non-Urgent Crossing Status: Found UCIP Comments: No permit identified for this crossing. FIELD_STRUCT_DESC: 4-inch steel communications conduit through the levee, at an unknown depth. Junction box off the landside (LS) toe next to JP and roadway. Conduit visible on upstream side of bridge at Deer Creek crossing. FS Date: 10/2/2013

Conduit visible on WS slope and at upstream side of bridge.

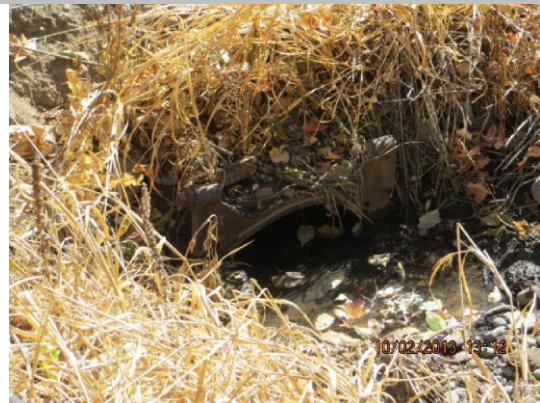
Photo 1 of 3 : UCIP_SP_2018_51438_36925.jpg

Comment Code						
Inspector Comment						
FS_ID:51438 DS_ID:20769 EP_NO: N/A Repair Type: Urgent Crossing Status: Found UCIP Comments: 12/05/2016 same as last inspection. Crossing remains "Urgent" WS opened during flood season due to damaged flap gate. (O. Magana - DWR UCIP)10/02/2013 Flapgate missing or burried on WS toe. Pipe partially blocked by soil on WS toe. (W. Wylie - DWR UCIP) FIELD_STRUCT_DESC: 24-inch corrugated metal drainage pipe through the levee, 7 feet below the crown. Flap gate located on the waterside (WS) end. A 5-foot by 5-foot concrete control structure located on the landside (LS) toe. [Additional Reference(s): DWR Levee Log, 1992. USACE Sacramento O&M Manual Unit 509, March 1957, As-built drawing no. 50-4-2394 (Station 176+10)]. FS Date: 12/5/2016

Pipe on WS toe with flapgate hinges.

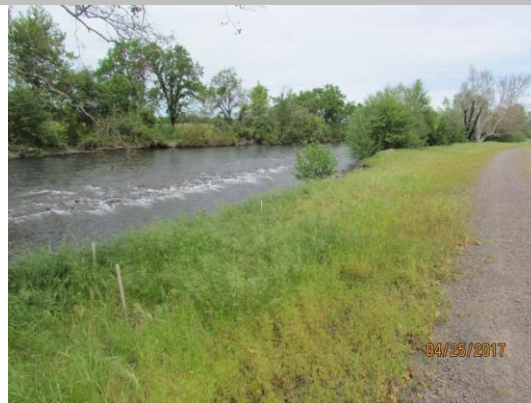
Photo 1 of 1 : SP_2018_NA0019_78_43_20180305_00017.jpg

View of erosion along waterside toe.

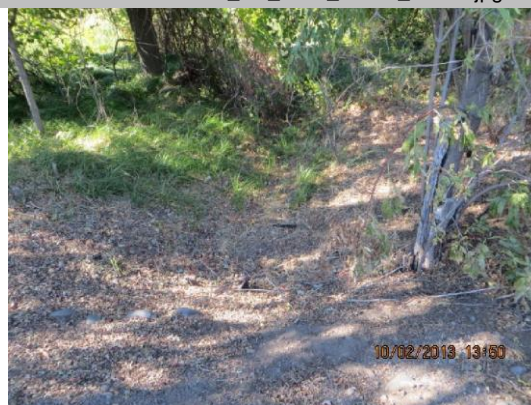
Photo 1 of 2 : UCIP_SP_2018_22824_38946.jpg

LM Start	2.86	Rating **	M	Issue No.	284
LM End	2.86	Issue Type +	Ma	Location *	
Category	Supplemental			GPS Latitude/Longitude	
				Start	End
Item	DWR UCIP LMA Responsibility			39.963938 °	39.963938 °
				-122.030128 °	-122.030128 °
DWR ID					
Comment Code					
Inspector Comment					
FS_ID:22824					
DS_ID:20767					
EP_NO: N/A					
Repair Type: Non-Urgent					
Crossing Status: Found					
UCIP Comments: Pipe blocked by soil.					
FIELD_STRUCT_DESC: 24-inch corrugated metal drainage pipe					
through the levee, 6 feet below the crown. Flap gate on the waterside					
(WS) end. [Additional Reference(s): DWR Levee Log, 1992. USACE					
Sacramento O&M Manual 509, March 1957, (Assumed Station 137+50)					
Drawing No. 50-4-2394].					
FS Date: 10/2/2013

Flapgate blocked by soil and debris.

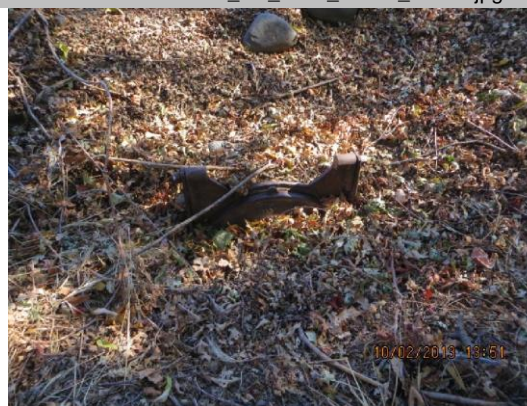
Photo 2 of 2 : UCIP_SP_2018_22824_38945.jpg

Flapgate blocked by soil and debris.

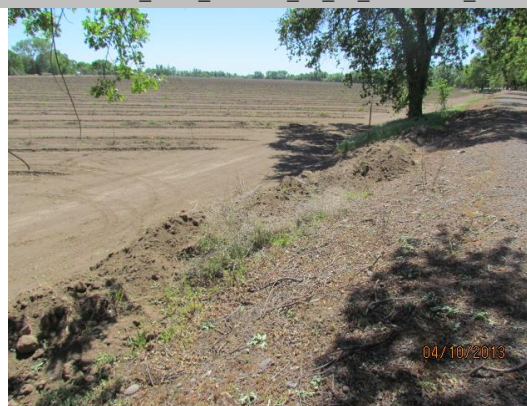
Photo 1 of 1 : SP_2018_NA0019_78_20_20180305_00008.jpg

View of the erosion along the landside slope.

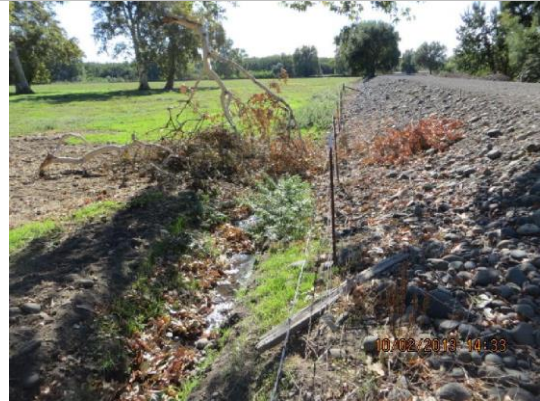
Photo 3 of 3 : UCIP_SP_2018_22825_38953.jpg

Low spot on LS toe where water disappears from levee toe. Unable to identify exact location of pipe on LS toe.

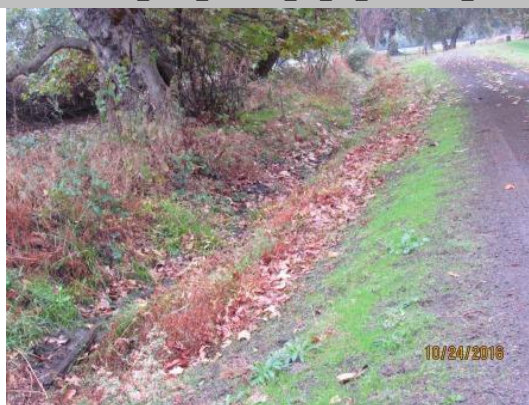
Photo 1 of 1 : SP_2018_NA0019_78_35_20180305_00011.jpg

View of the vegetation along the landside slope and toe.

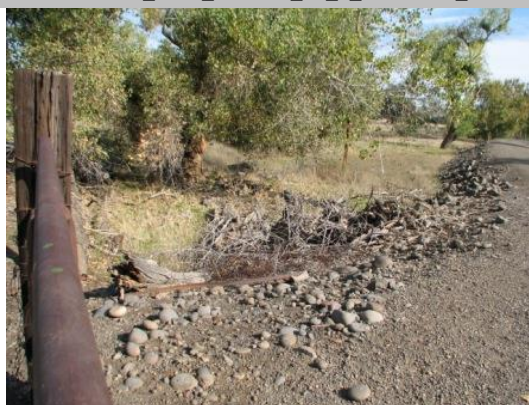
Photo 1 of 1 : SP_2018_NA0019_79_2_20180305_00001.jpg

View of debris and wire at the toe of levee.

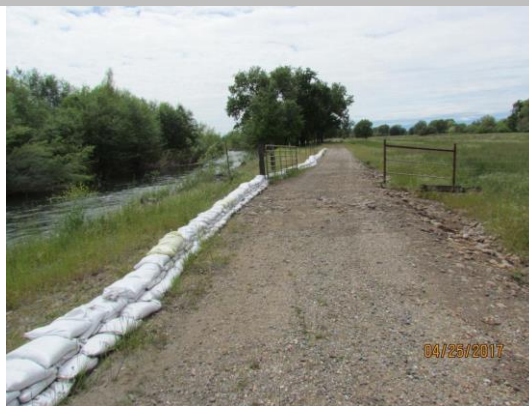
Photo 1 of 1 : SP_2018_NA0019_79_12_20180305_00007.jpg

View of the erosion on the crown roadway.

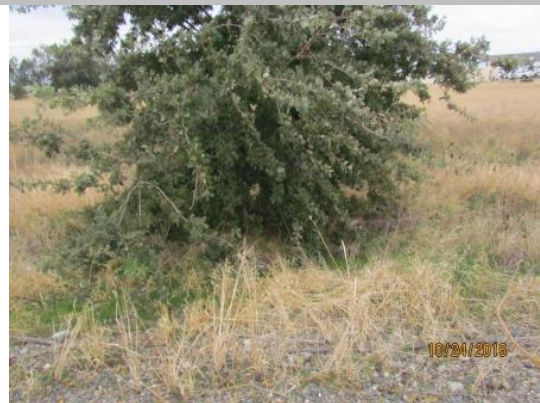
Photo 1 of 1 : SP_2018_NA0019_81_13_20180305_00008.jpg

View of a tree with overhanging branches.

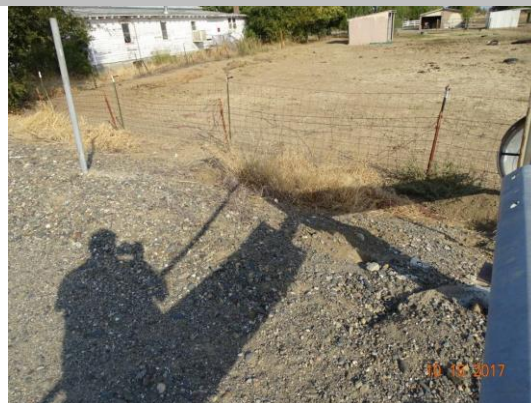
Photo 1 of 1 : SP_2018_NA0019_81_51_20180305_00024.jpg

View of the rodent holes along the landside slope.

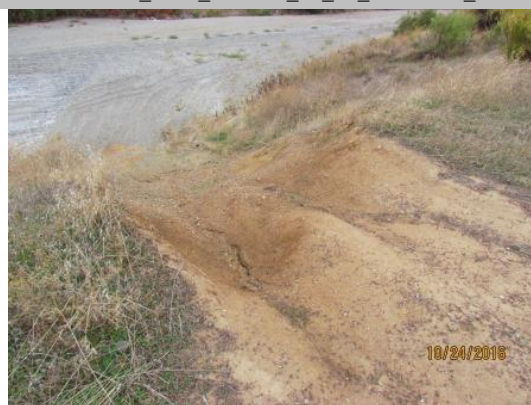
Photo 1 of 1 : SP_2018_NA0019_81_29_20180305_00017.jpg

View of the slope instability caused by vehicles along the waterside slope.

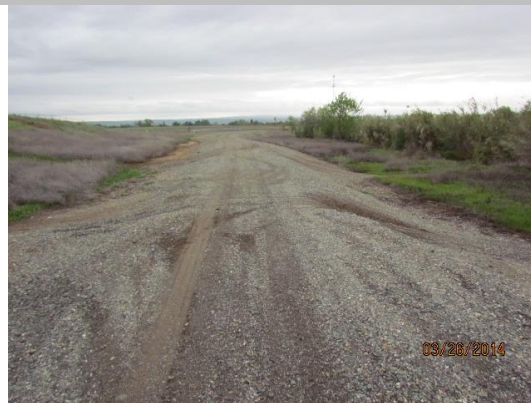
Photo 2 of 2 : SP_2018_NA0019_81_3_20180305_00004.jpg

View of the levee slope damaged by vehicle traffic.

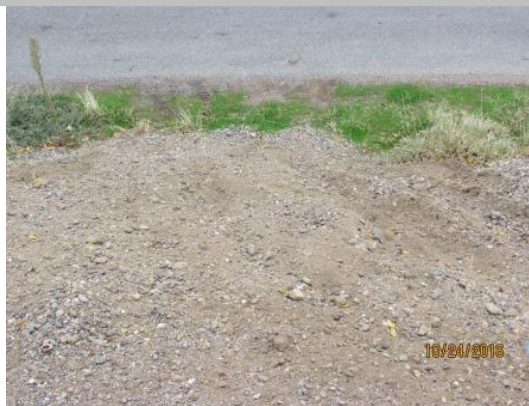
Photo 1 of 1 : SP_2018_NA0019_81_30_20180305_00018.jpg

View of the slope instability caused by vehicles along the landside slope.

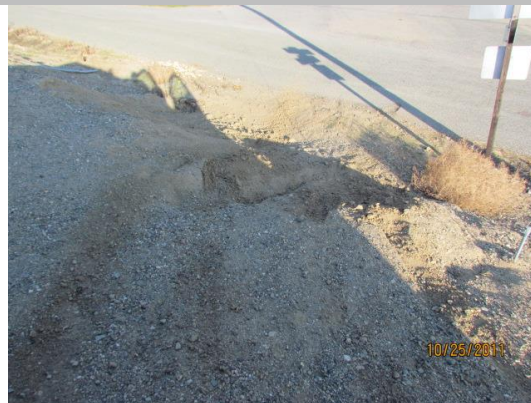
Photo 1 of 1 : SP_2018_NA0019_81_20_20180305_00013.jpg

View of the slope instability caused by vehicles along the landside slope.

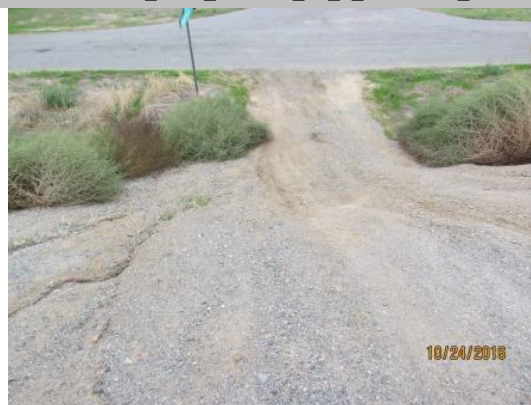
Photo 1 of 1 : SP_2018_NA0019_81_2_20180305_00002.jpg

View of the slope instability caused by vehicles along the landside slope.

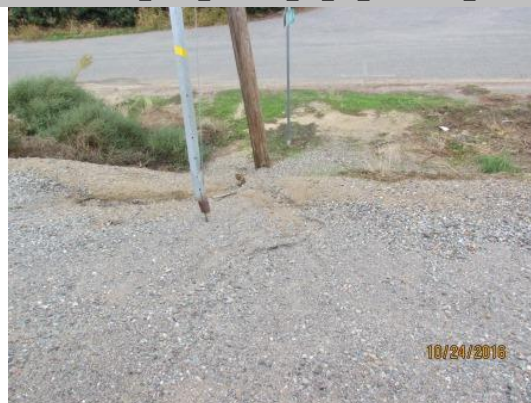
Photo 1 of 1 : SP_2018_NA0019_81_32_20180305_00020.jpg

View of the slope instability caused by vehicles along the landside slope.

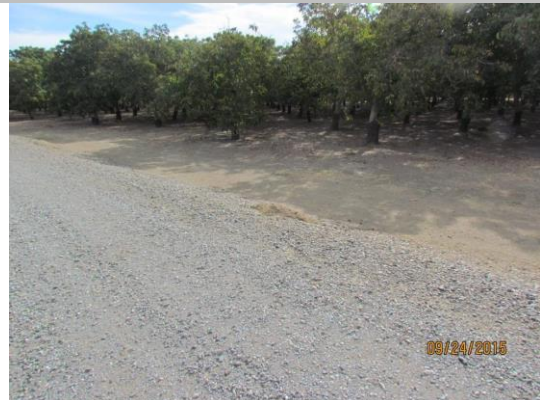
Photo 1 of 1 : SP_2018_NA0019_82_8_20180305_00003.jpg

View of the rodent holes along the landside slope.

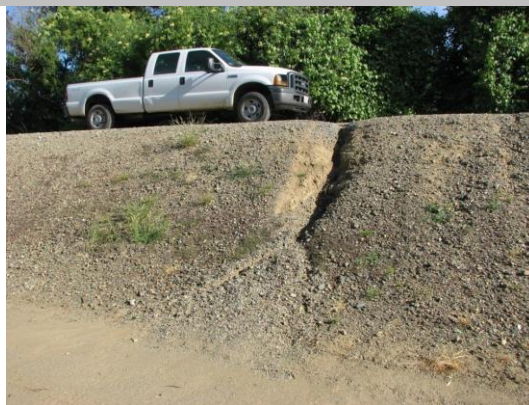
Photo 1 of 1 : SP_2018_NA0019_82_10_20180305_00004.jpg

View of the erosion along the landside slope.

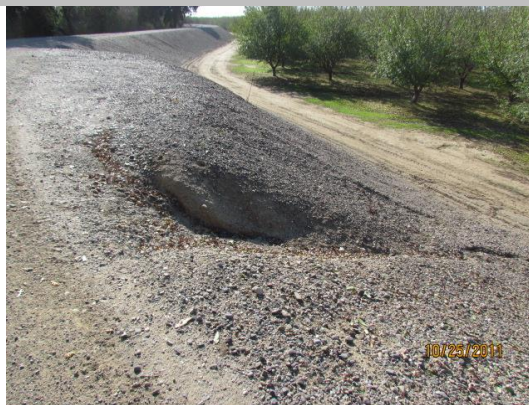
Photo 1 of 1 : SP_2018_NA0019_82_7_20180305_00002.jpg

View of the erosion along the landside slope.

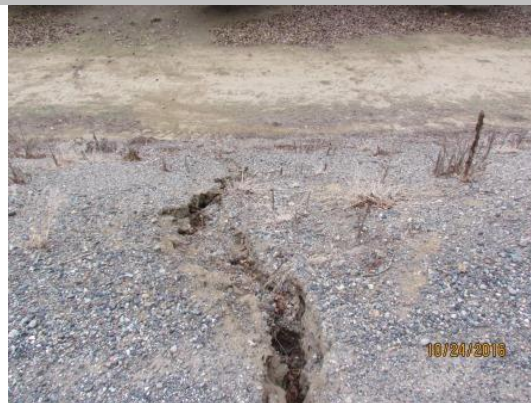
Photo 1 of 1 : SP_2018_NA0019_82_19_20180305_00008.jpg

View of the erosion along the landside slope.

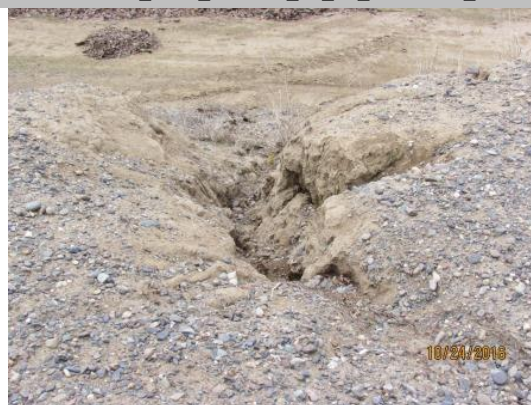
Photo 1 of 1 : SP_2018_NA0019_82_18_20180305_00007.jpg

View of the erosion along the landside slope.
